Historic Structure Report

June 2002

**Bodie Island Lighthouse
at
Cape Hatteras National Seashore
North Carolina**

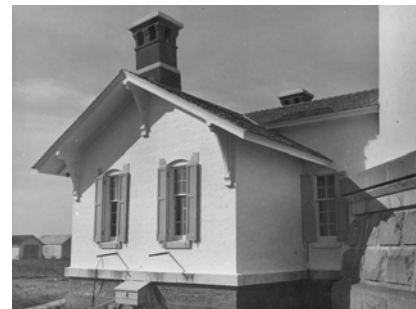
1948 USCG Photo of
South Elevation

South Elevation: The south elevation is a mirror of the north elevation in composition. Like the north elevation, the south elevation exhibits a dormant and repaired crack from the west corner of the east window downward and to the east. In addition, there appear to be several patches in the elevation that have repaired brick damage, likely spalling. One patch is over the head of the east window, and one is at the east side and below the sill of the west window. Evidence of spalled brick can be seen on the lower east corner of the elevation below the water table.

There are two patched holes in the center of the elevation below the water table and above the inset in the wall. Earlier photos suggest these patches mark the location of what appear to be drain outfalls from the Oil Room. Mid-20th century photos also indicate the location of a box mounted to the south wall below the water table. The brick shelf defining the inset brick panel below the water table was partly removed to accommodate the box sometime between 1930 and 1948. A portion of a bracket, likely part of the anchorage system for the box, remains attached to the wall. The windows on this elevation are 4/6 like those on the north elevation. However, the east window on the

south elevation has a metal screen on a wood frame attached to the window frame. Also present are five brackets for shutters that no longer exist.

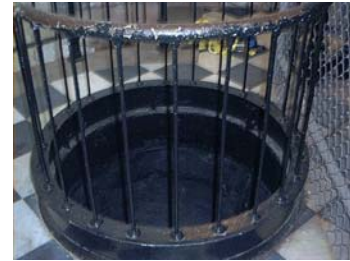
Well: In the center of the ground level is a depressed well approximately 30" deep protected by an original cast iron railing 38" high. The well is constructed of cast iron, with a cast iron wall and cast iron floor, the entire assembly being painted black. The well and railing are in sound condition. The well was reportedly constructed to receive weights used in the operation of a mechanism that would allow the light to "flash." However, the mechanism was never installed, and, thus, the well was never used as intended in the original design.

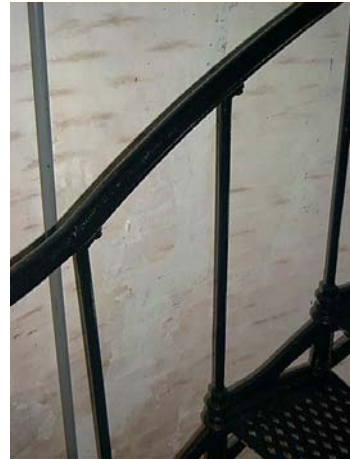
The handrails of the stairs and landings were not analyzed for strength. They do not meet current safety codes, which require a 4" or less space between pickets. Modifications to these handrails to meet codes will result in non-historic treatments. One of these treatment options would be to fabricate and install new handrails with the proper spacing. Another would be to install a non-clouding, rigid plastic barrier or a mesh at the railings to prevent falls. Though neither of these options represents an historic treatment, the second is a more reversible modification that is easily identifiable as non-historic, while the first would be permanent and might be mistaken by visitors as representing an original installation.

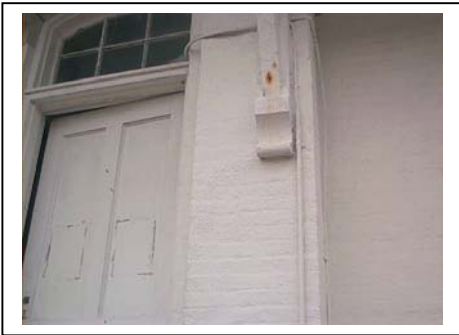
Photo 2

The routing of the service conductors and grounding cable run from the utility meter (see photo 2) to above the door of the Oil House entrance (see photo 3), penetrates the door (see photo 4), is routed across the south wall of the Hall to above the Oil Room door (see photo 5), and penetrates the door to the distribution panel (see photo 6).
